Has the Transformer Failed?

Hydro-Québec goes proactive to ensure line worker safety, improve customer satisfaction and increase operational efficiency.

by Daniel Desrosiers, *Hydro-Québec*

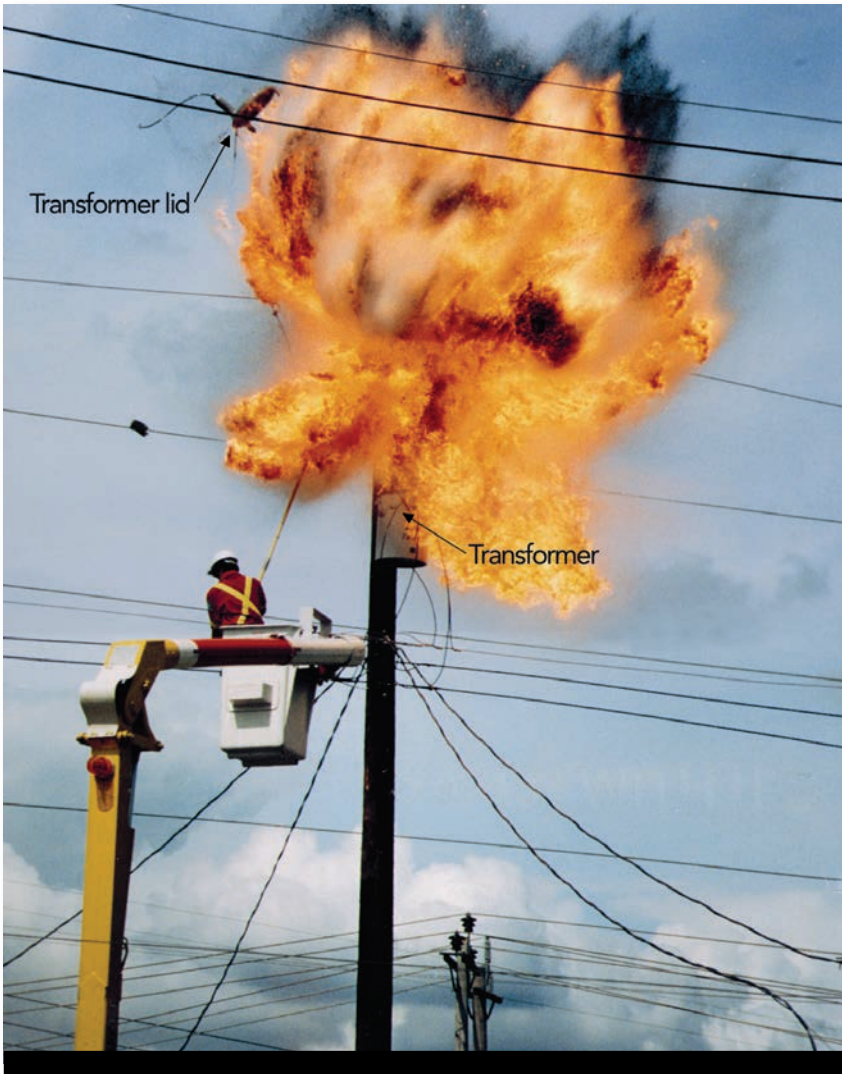
This is the possible result of reclosing on a transformer with an internal fault. This photo was staged at a utility test lab with a mannequin, not a line worker, and the reclose onto the line voltage was done remotely.

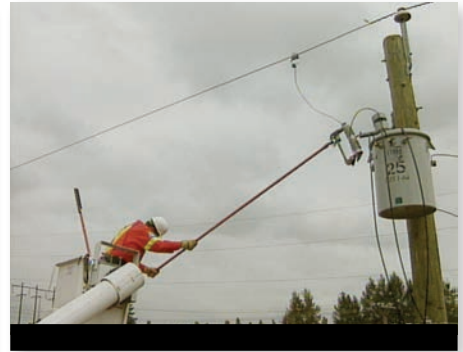
A typical shot of a line worker reclosing a re-fused cut-out. Without an IFD there is no way to know the consequences of this action.
