Is Your Transformer OK?

Enhanced safety is the reason PG&E has internal fault detection on all new overhead transformers.

By Roozbeh Movafagh, Pacific Gas and Electric Co., and Dan Mulkey, Mulkey Engineering

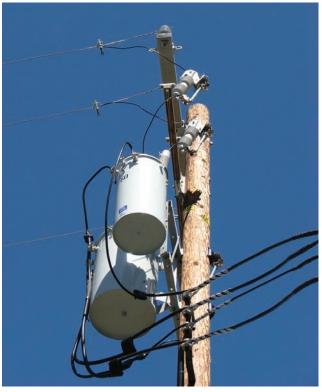
A typical overhead transformer installation with fused cutouts before the adoption of the use of internal fault detection.

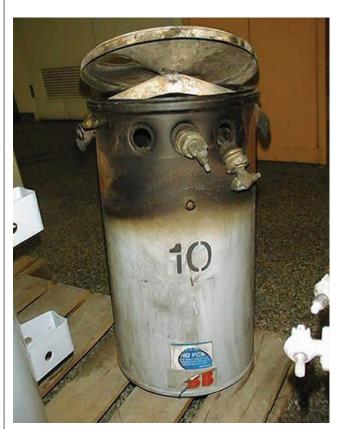
The force of an internal fault inverted the lid, which is still attached to the center post, causing a catastrophic failure.

An internal fault can be violent enough to blow the lid off a transformer.

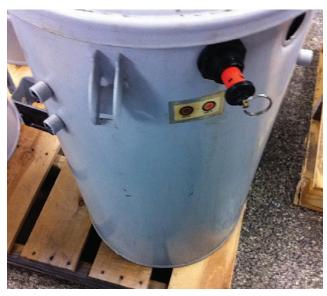
This transformer was returned to the shop after failing in the field. The IFD has popped and the exposed red is easily visible, even from the ground.

For transformers with an IFD, PG&E has modified its procedure so, if the IFD indicates a fault, the lineman always changes out the transformer regardless of the number of fuse operations. If the IFD does not indicate a failure, then even if two or three fuses have blown, it is fine to install new fuses and try the transformer.

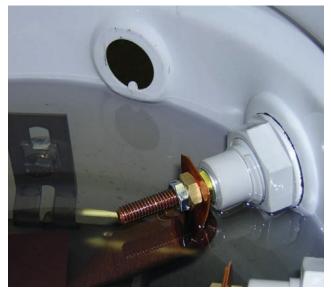
As shown from the inside, the IFD is installed through a hole in a flat area of the transformer case.

The IFD includes a PRV, so the pressure can be reduced when it is necessary to open up the transformer. But it also indicates when there has been a sudden rise in pressure, and that is the key. During a low-impedance internal transformer fault, there is not a gradual buildup of pressure like when a transformer heats up as a result of high loads or rising ambient temperatures. The low-impedance fault generates an almost instantaneous pressure spike. This triggers the IFD, popping out the red flag and warning the lineman. Such a low-impedance fault is the most dangerous kind of fault, as re-energizing the unit can result in the transformer cover flying off.
